## **Bombardier Transportation: Ilford Extraction Fan**

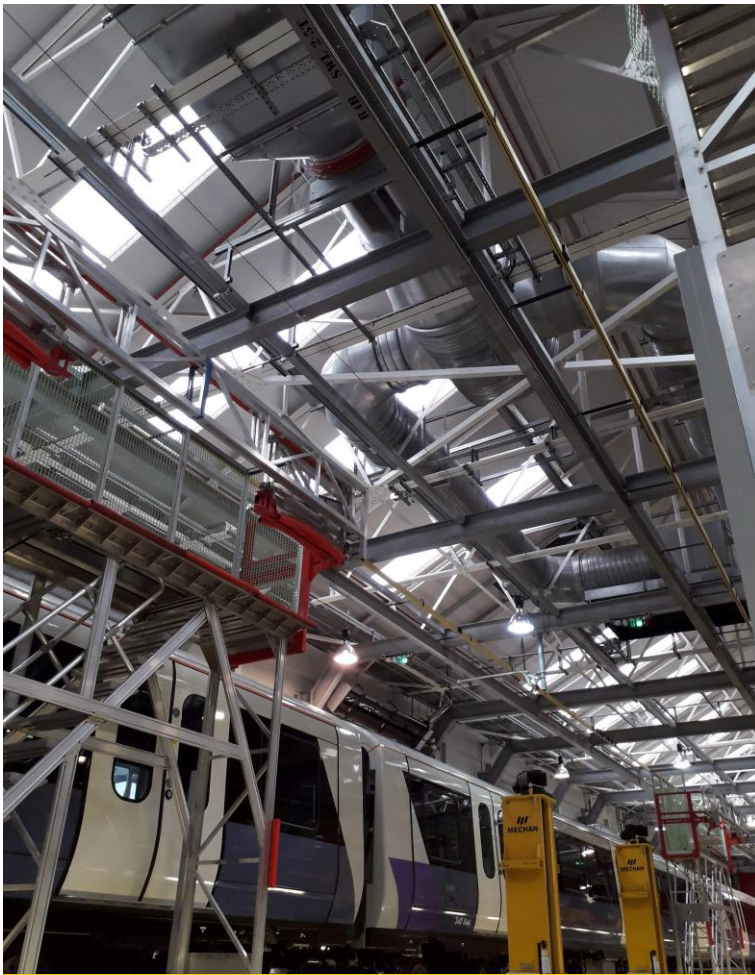
Fan shown in roof apex

The fan was situated in the roof apex with no means of access. Obstacles above the trains and equipment included:

- 25KV power lines
- Runway beams and conductor systems
- Fire alarm cables and pipes
- Old lattice and new beams for the building structure

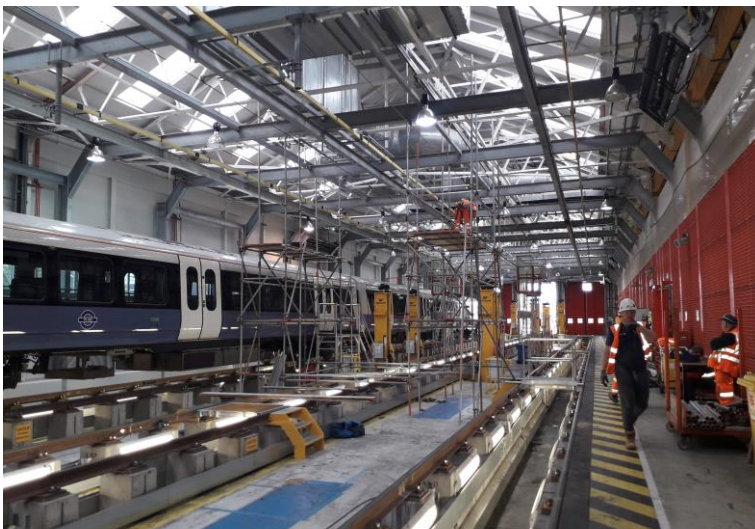
Installing scaffolding

- Once designed and approved, scaffolding was installed.
- Each piece having to be walked over 100 metres.

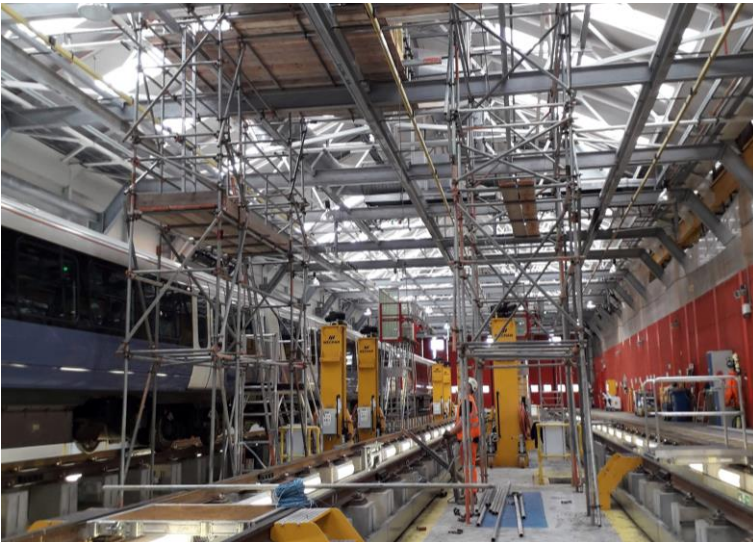
Twin tower scaffolding design

- The 4000kg lifting beam for the fan was integrated into the scaffold.
- The twin tower design allowed trains to pass safely on all three 'roads' during the task without interfering with any high-level cables or beams when operatives were not on site.

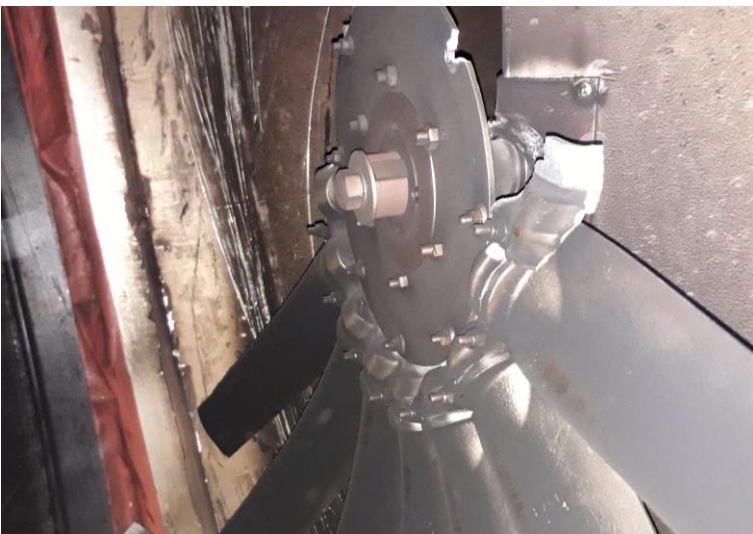
Damaged extraction unit

- Once completed, Street Cranexpress engineers removed the fan cowling.
- The extent of the damage was noted.
- The damage meant that the fan could no longer be used.

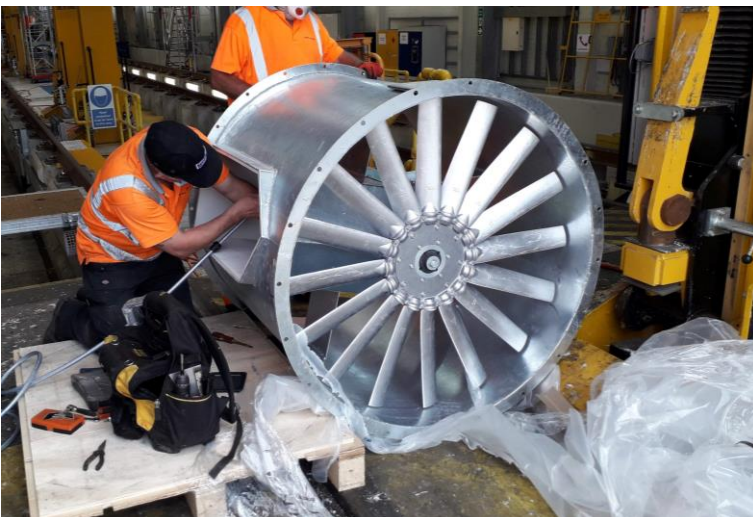
Preparing the replacement fan

- The replacement unit was prepared at ground level for installation.

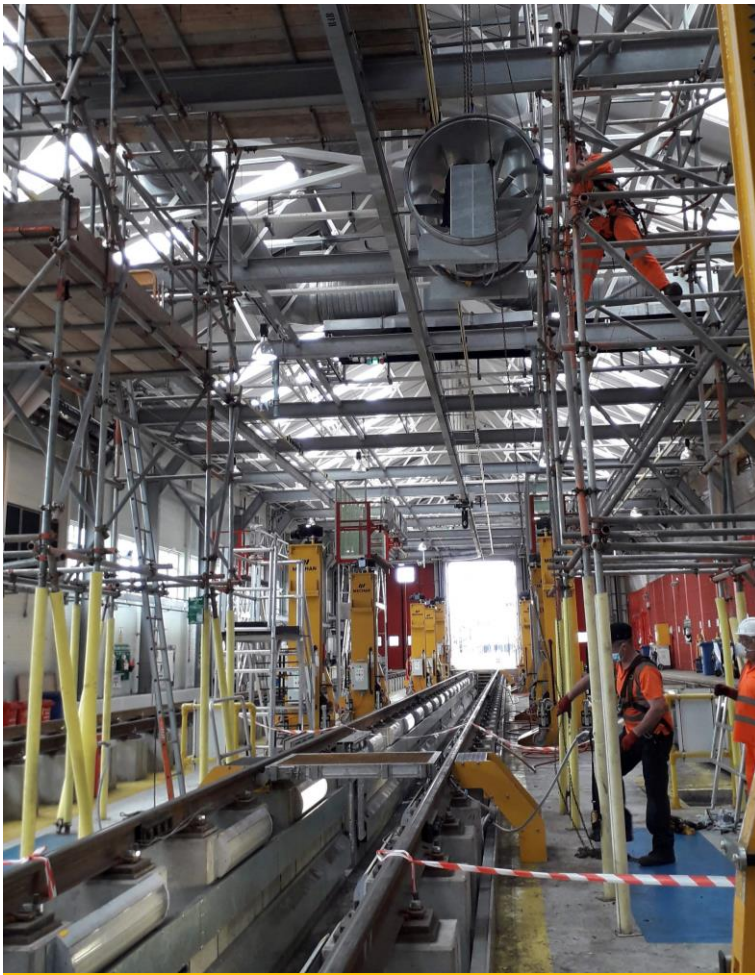
Lifting the new fan

- The old fan was lowered.
- The new unit was then lifted through the maze of obstructions via a gap approximately 20mm larger than the fan itself.

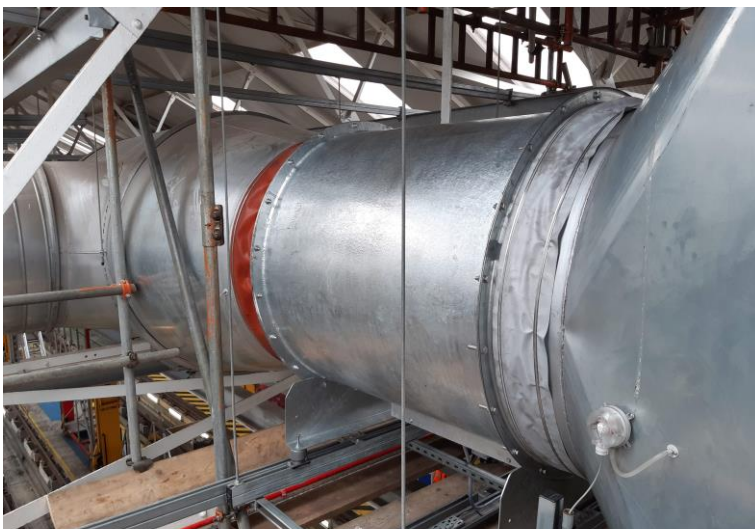
New fan installed

- The new fan was traversed into position along the lifting beam and installed.
- The fan was tested to run at full speed, and it performed excellently.
