Lamella Crane Replacement Hoist Case Study

The Challenge

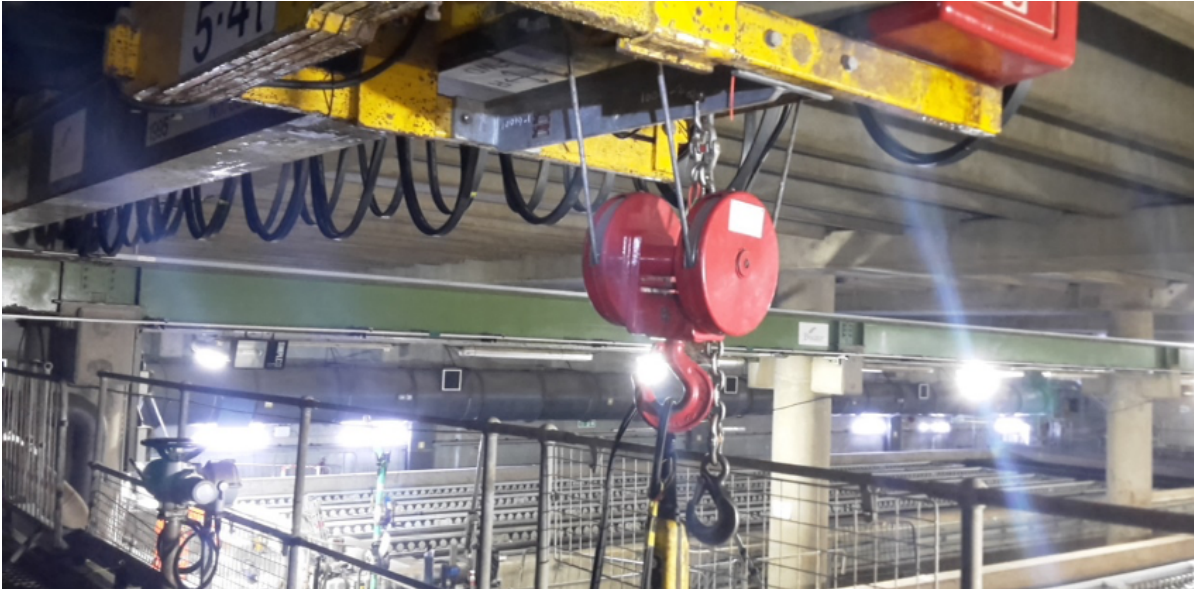
Original hoist

- The existing hoist had been modified without approval from the OEM by a previous contractor.
- The securing bolts were in direct shear and there was no evidence of a proof load test.

The lifting beam had been bolted to the cross members of the 5t hoist, but the location where the holes had been drilled could have affected the integrity of the cross-member box section as they were in direct shear and the modification had not been approved by the original equipment manufacturer.

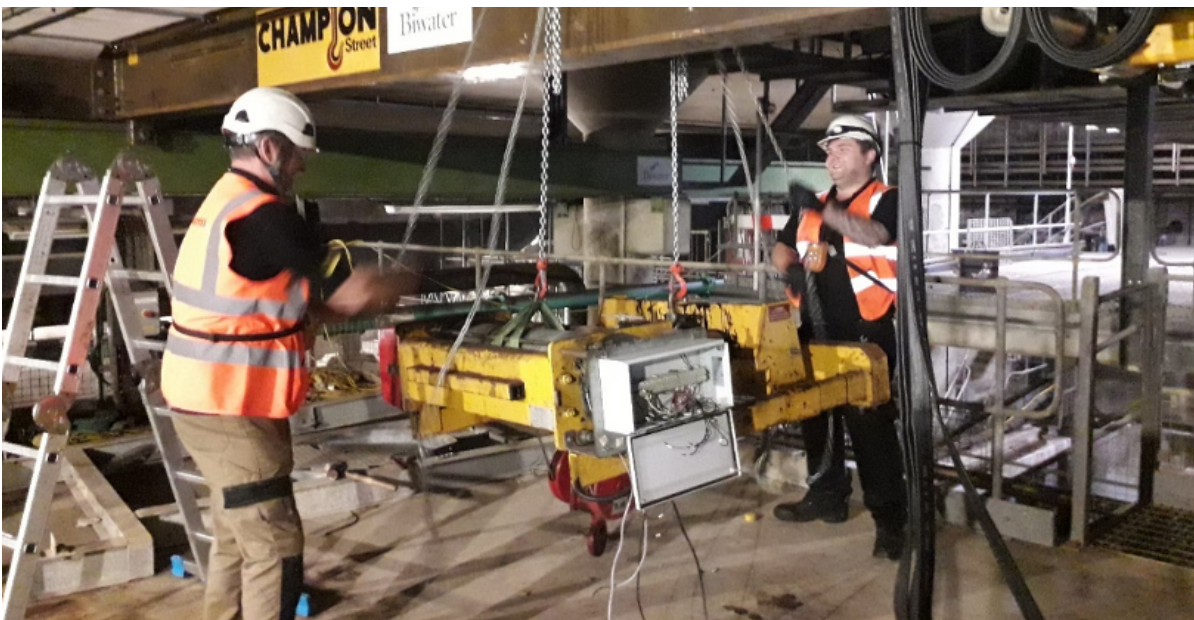
Street Cranexpress Engineers lowering the old hoist

- The existing 5t wire rope hoist was lowered from the crane bridge using a certified lifting tree and two chain blocks simultaneously.
- The original hoist was lowered and placed onto a high-level platform.

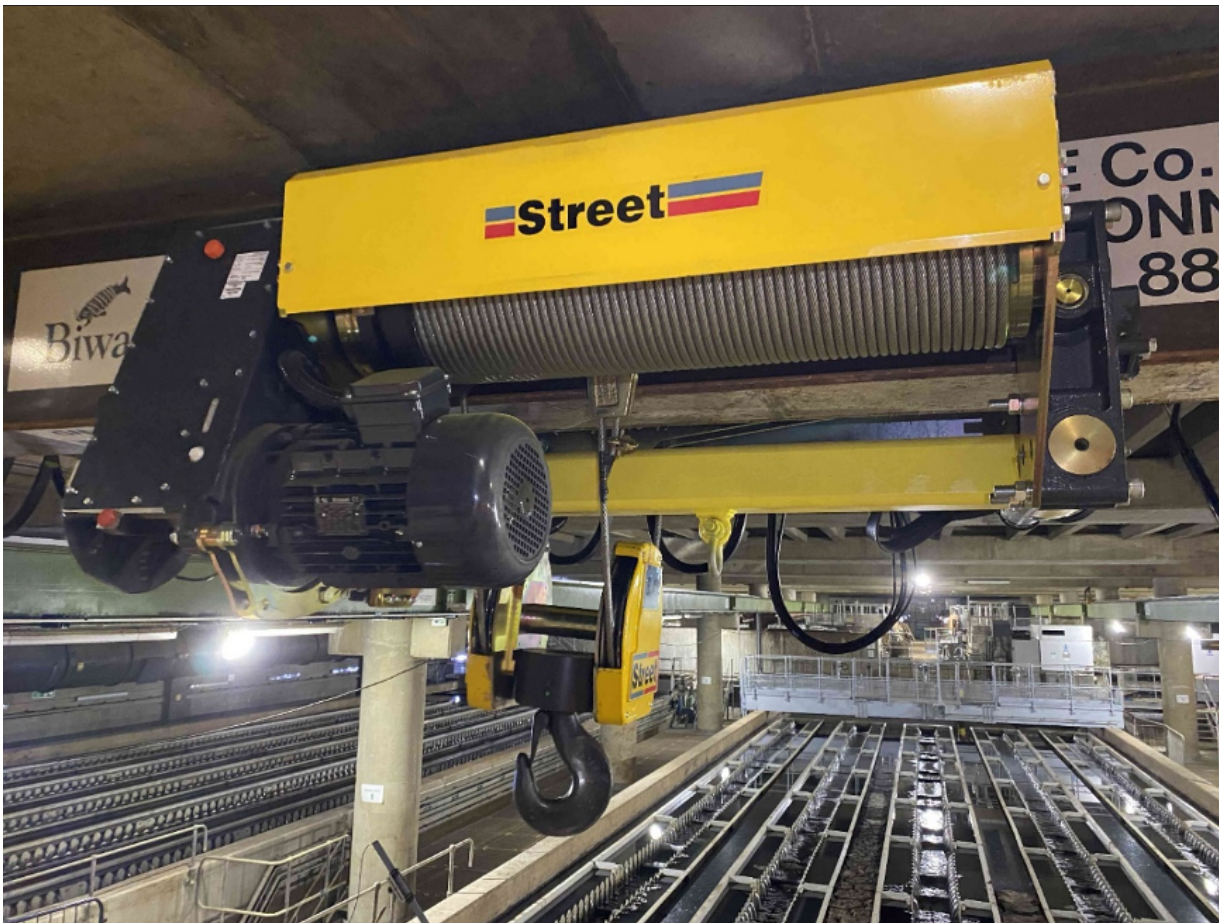
- The new lifting beam was fabricated using two tubular pipes, connected by a crossmember section.
- The cross member had a 3t dedicated lifting point with a 3t D Shackle attached.

Street Cranexpress designed, manufactured, and installed a bespoke 3t lifting beam on the solid steel round span bars. The lifting beam was constructed using two tubular pipes connected by a crossmember.

This method kept the chain hook attached to the lifting beam central to the 5t wire rope hoist allowing a smoother, safer lift.

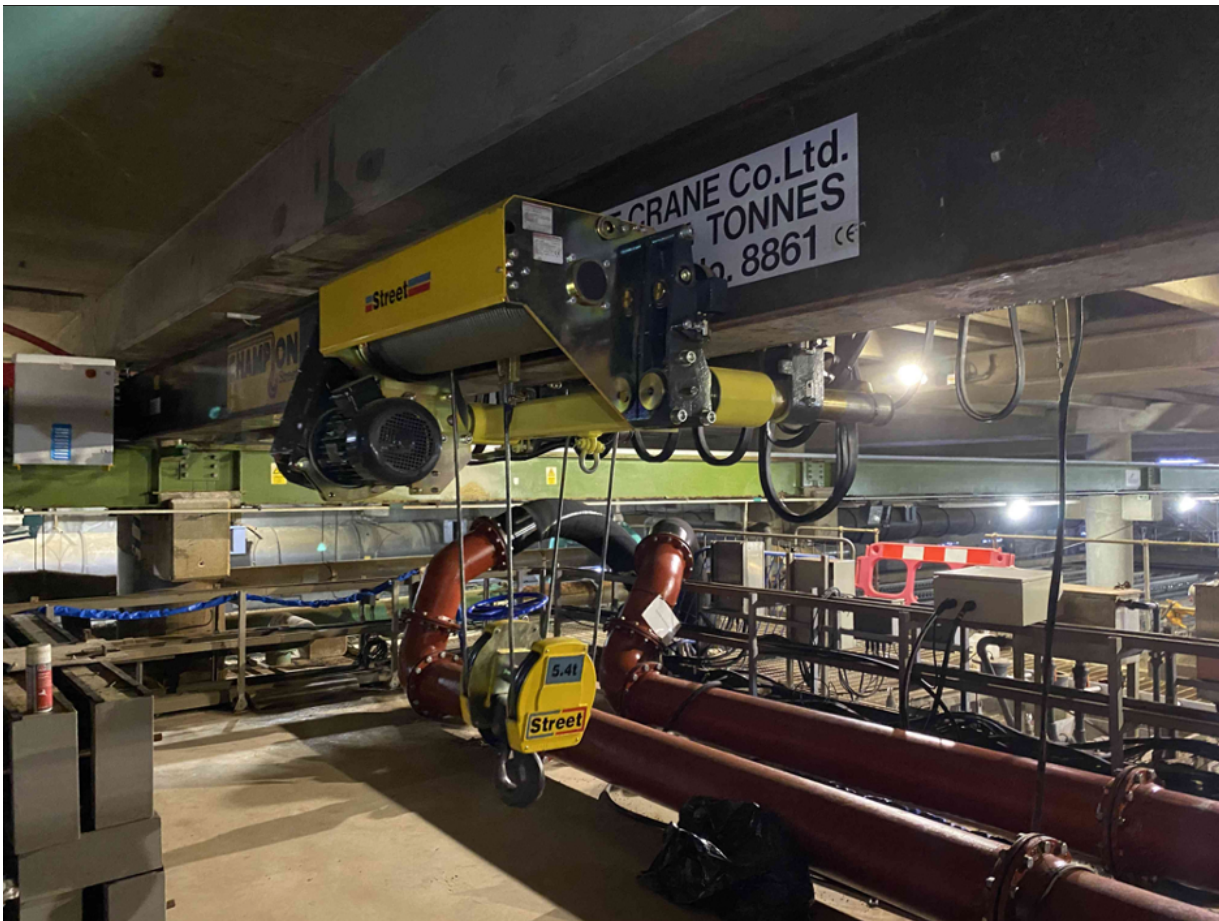
- The replacement hoist had been tested at our engineering workshop prior to installation.
- Once on site, the new Street ZX8 hoist unit had to be lowered underground to its new location using existing cranes on site which are maintained by Street Cranexpress quarterly.

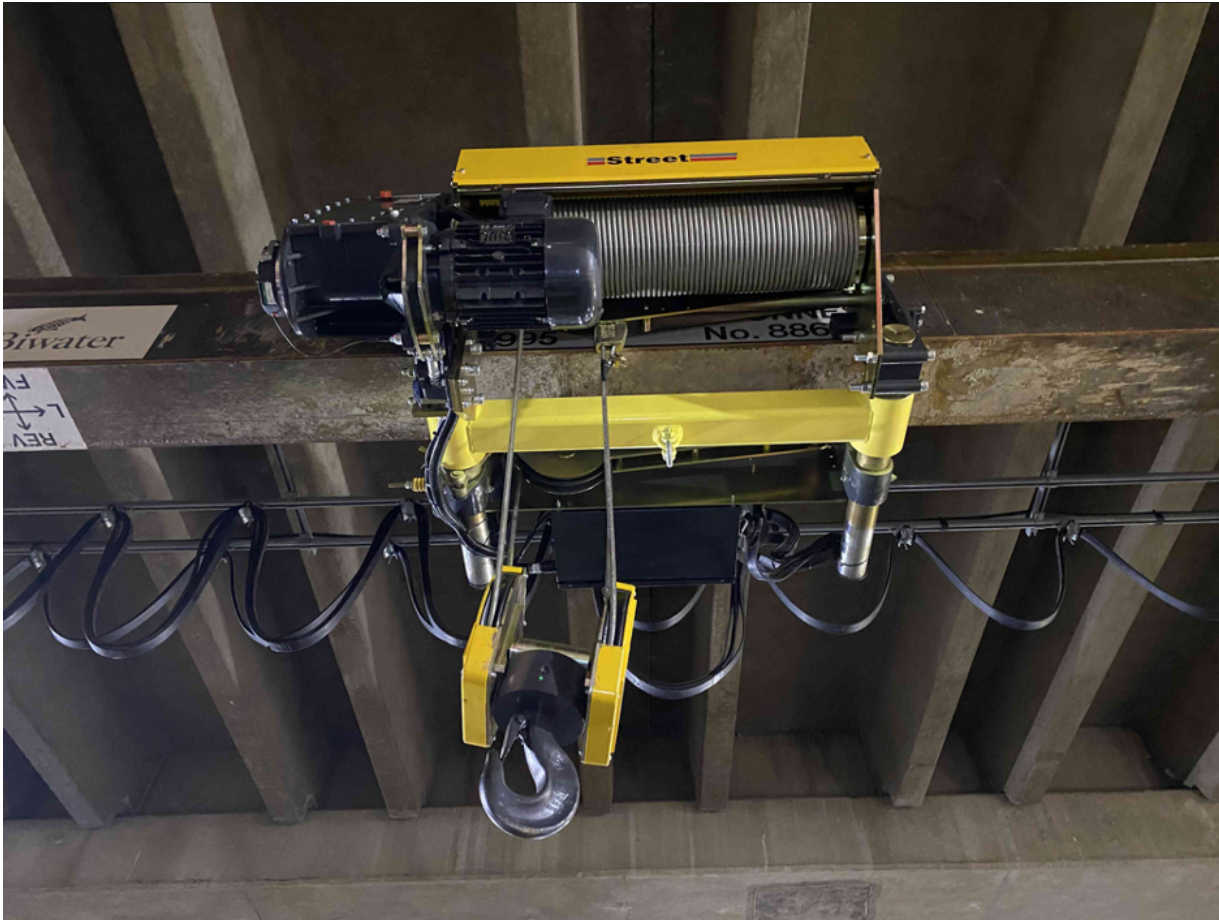
Proof Load Test

- A proof load test was conducted on the 5t wire rope hoist.
- A Report of Thorough Examination was then carried out on the hoist before it was put into service.
- Its first lift was to take the old hoist from the high level to the lower level. That was then moved between bays using an existing bogey to a position it could be lifted to the surface and removed from site.
